Mitsubishi: Блок Управления

In this article we will talk about the methods of inspection and repair of the ECU of the Mitsubishi cars of the early 90-ies of release.

Take, for example, the real situation - the 1991 Mitsubishi Galant car, the 2.0L 4G 3G 8 valve engine. The engine does not start, the "CHECK" lamp does not light on the instrument panel when ignition is turned on.

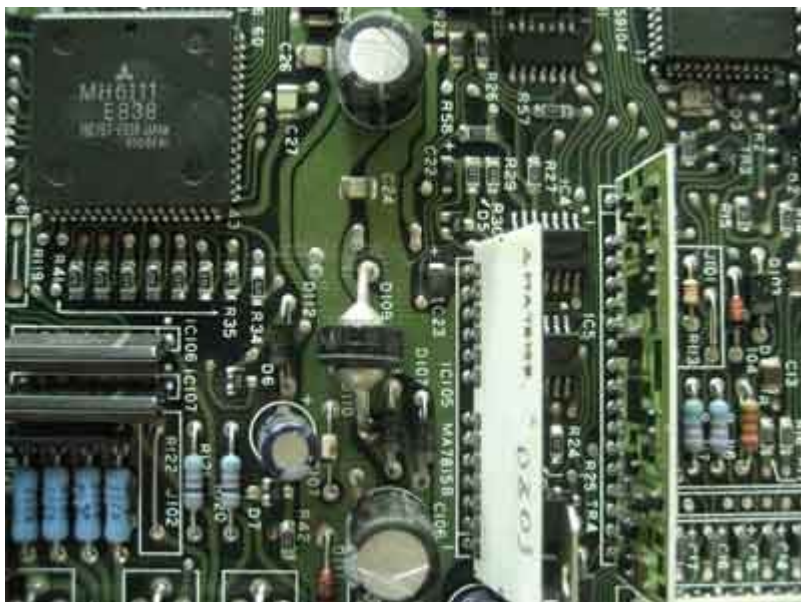
Here is a living example - outwardly everything is beautiful ...

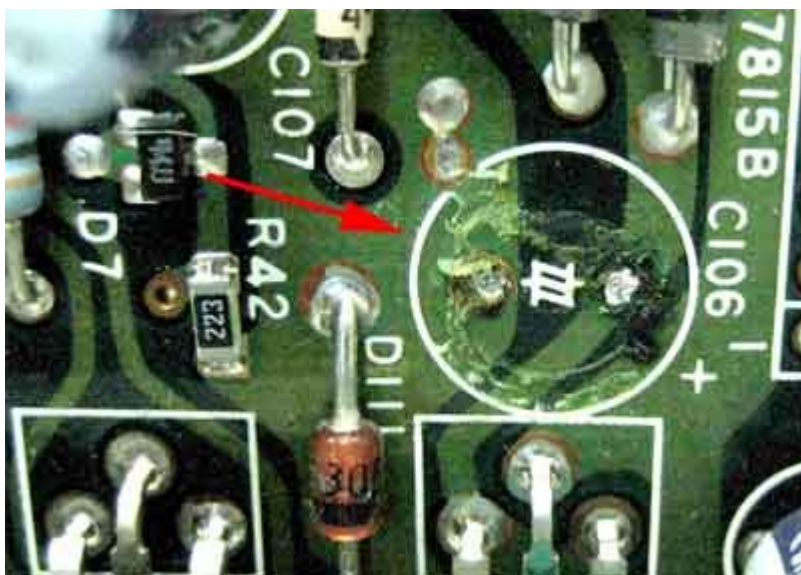
More than once discussed and many are aware of the reason for the most frequent failure of the unit due to the leaked capacitors in the food chains. Therefore, immediately pay attention to the capacitors, the presence of a leaked electrolyte under them and damage to the payment under them. Although if the capacitors are still factory, then it is better to replace them anyway.

And if you lose capacitors we see this picture:

I use $47\mu\text{F} \cdot 50\text{-}63\text{V}$ and $100\text{m}\mu\text{F} \cdot 50\text{-}63\text{B}$ respectively. Attention - temperature range I recommend 105 degrees!

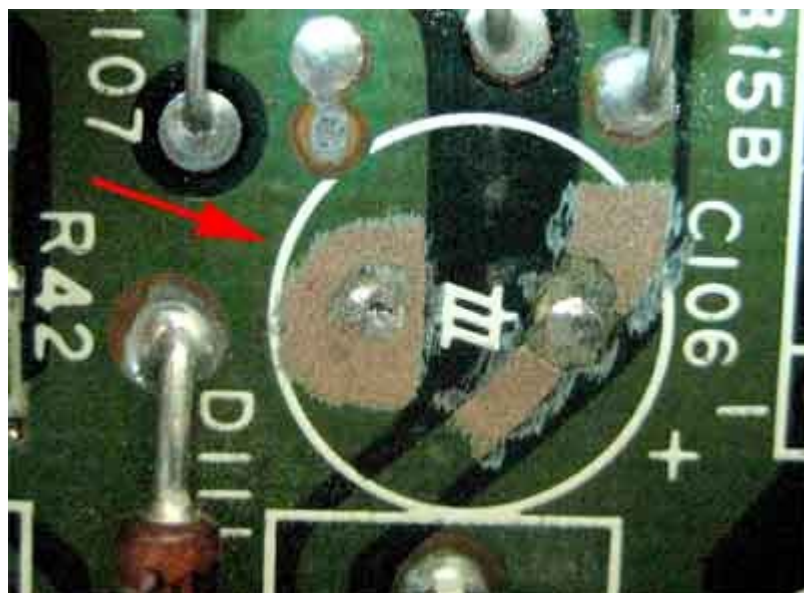
Replacement of capacitors also has its own characteristics, as a rule, under the capacitor there is already damage to varnish and paint on the board. In more severe cases, end-to-end metallization between the board layers rotates, the tracks rot.

Therefore, before you solder the new capacitor, the board in this place should be well washed with acetone or a solvent, clean the paths and places of soldering to copper, and bleed.

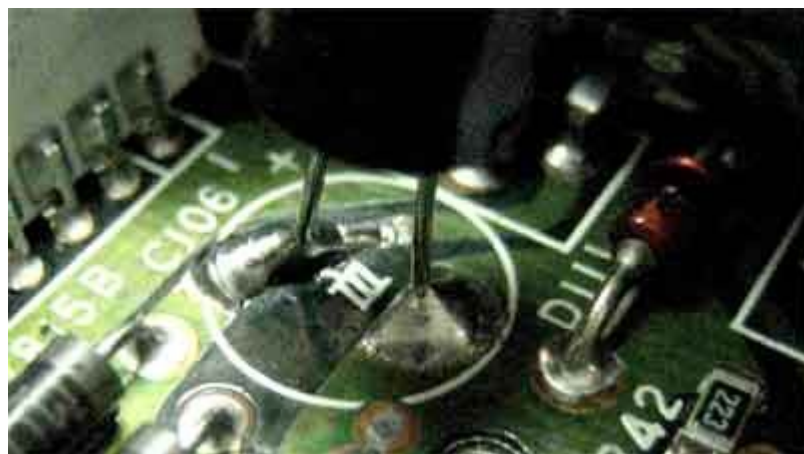
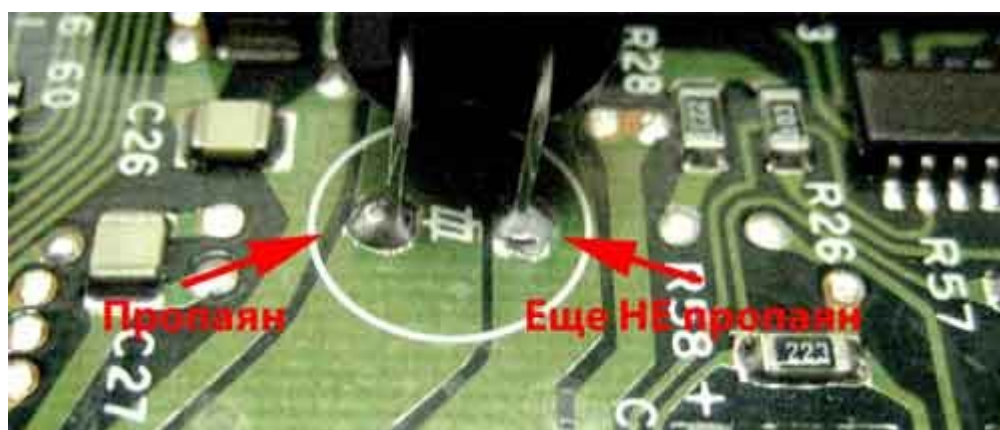
Particular attention should be paid to the capacitor 47 μ F standing near the radiator and a green transistor (on the radiator). The transistor acts as a 1-in-house vitamin stabilizer of 5v. From its properness and proper work depends on the work of the digital part of the unit. Due to damage to the area of payment under this capacitor often leads to an increase in the supply voltage of +5v to 12v, which is “murderative” to power the digital part (5h +-5%) to put it mildly “killful”.

capacitor inserted and soldered reliably on both sides as shown in

In this case, the damaged paths are restored, the board is well washed with acetone or solvent, the capacitors are replaced and only after that can be switched to the inclusion and verification of the block. In many cases, the check will show the performance of the block after the above measures.

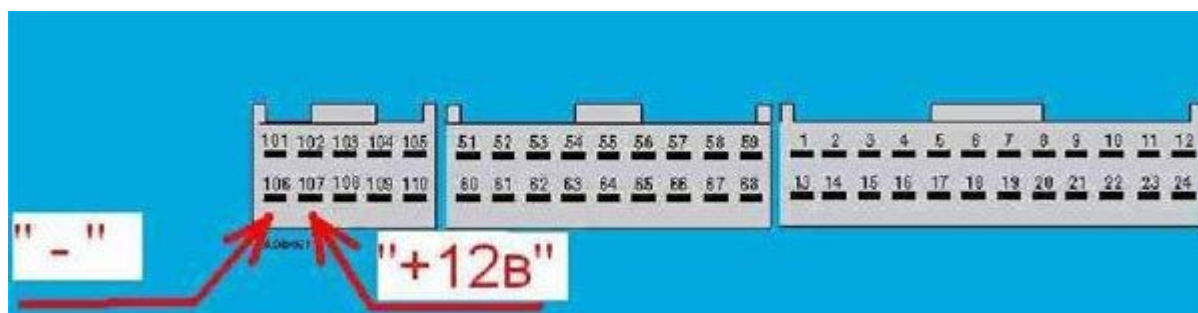
The consumption of a serviceable unit with such a connection is 160-210 mA.

To check the block, it is enough to serve the results as shown in the photo:

The power supply should be stabilized and issue a minimum of 0.5A at a voltage of 12Q.

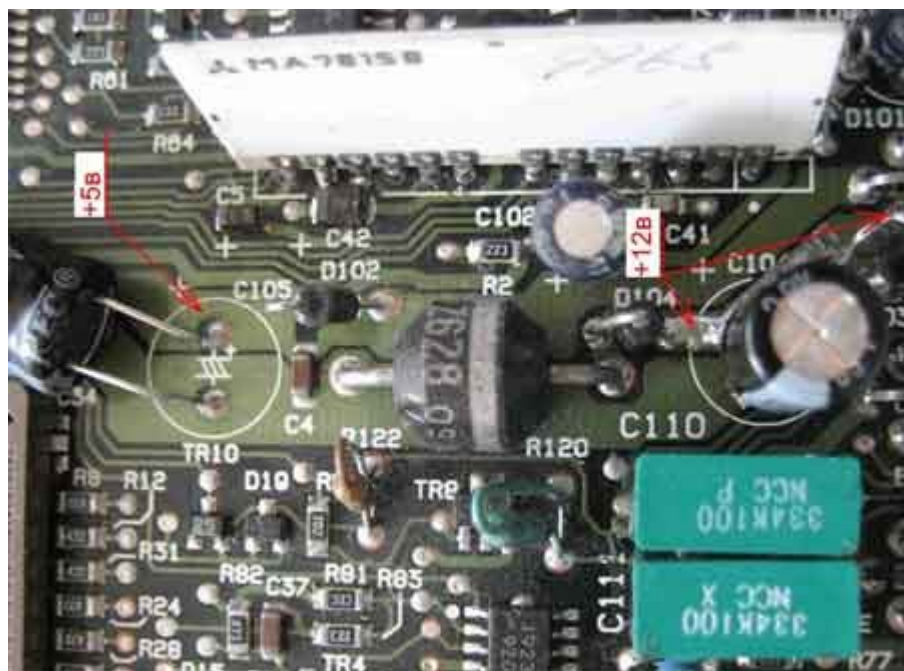
We measure the voltages at the specified points of payment. Different modifications of the blocks will differ in the arrangement of components, but the meaning of this is not lost, the capacitors in the power chains of 5v and 12v are present in any type of blocks.

The voltmeter should be used preferably digital, the deviation of the supply voltage +5B should not go beyond 4.9-5.1V.

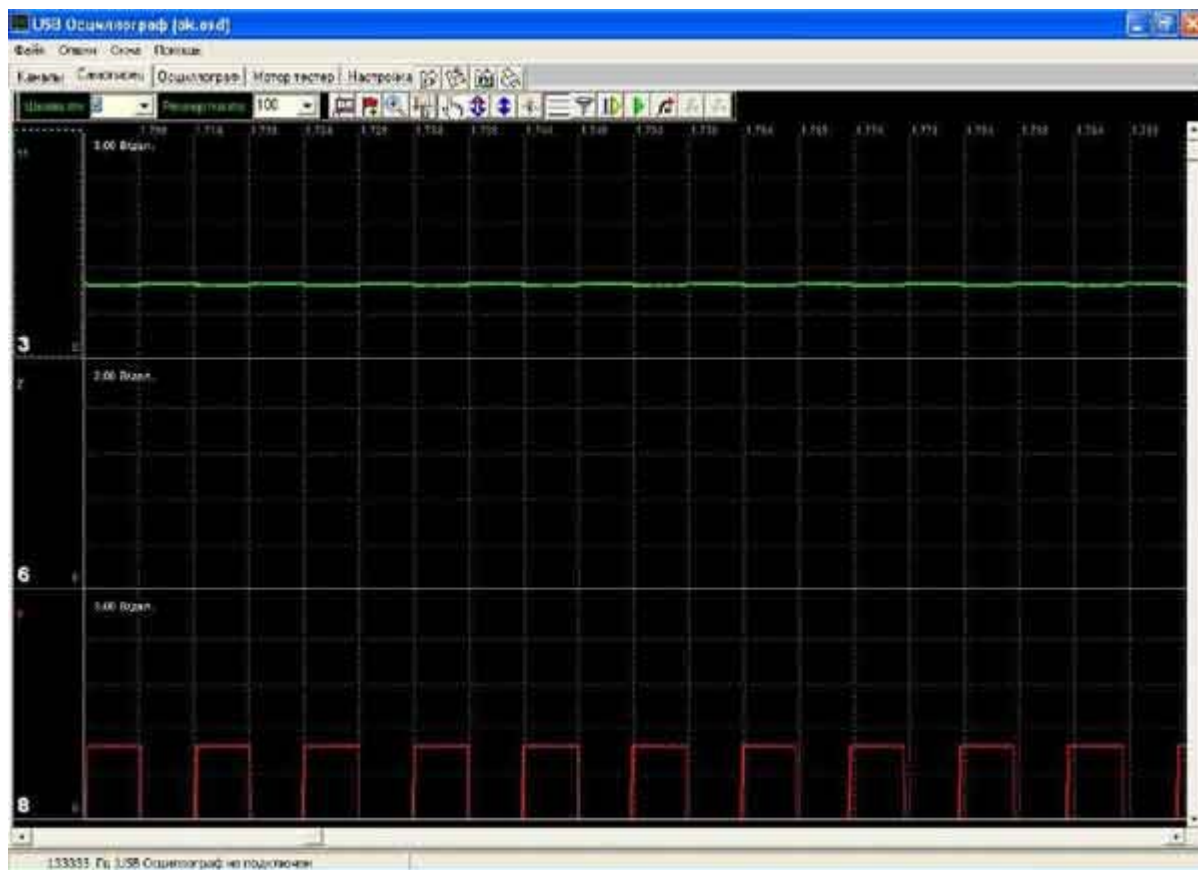
Oscillogram of the working block:

Channel 3 -11 pin Assembell Reset, about 5v.

Channel 6 – 7 pin

Channel 8 – 5 pin pulses of resetting the timer from the processor (confirmation that the processor is working and executes the program).

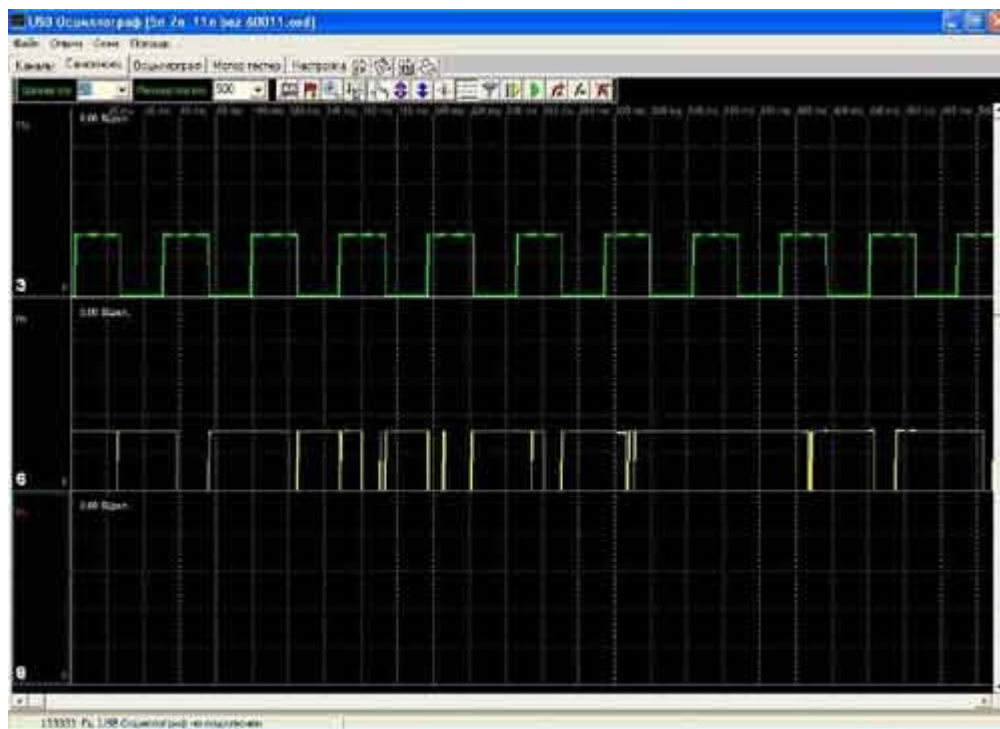
When the processor is faulty, in the block option without external memory, and / or malfunctioning port expander M60011 and/or ROM microscheme(Eprom)27C128 or 27C256, in the version with external memory, then on the assembly will be observed such a picture ...

There are no pulses to confirm the operation of the processor, and the watchdog timer is cyclically restarted by the processor, as evidenced by pulses on the 11th leg of ceramics (Reset).

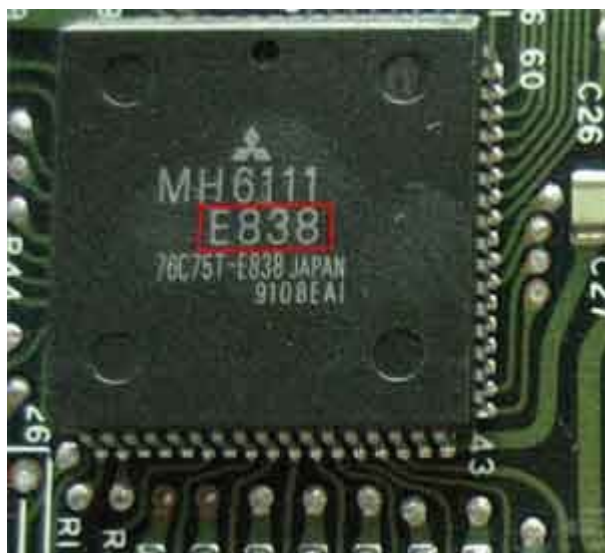
The problem is also aggravated by the variety of engine control programs (efle), in the version of the block without an external ROM, then the replaceable processor should have the same “mask” as the native one.
